# Manhole Inspection Summary

Manhole # S51G\_\_002MH

Insp Date: **9/17/08 10:28 AM**

**Location** Address: **100 patterson park**

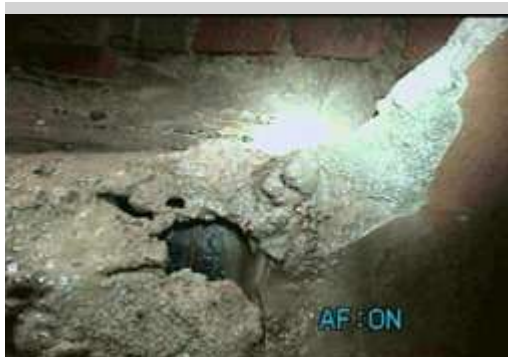
Defect 6

Condition: ☐ Sound ☒ **Cracked** ☐ Root Intrusion ☐ Deteriorated ☐ Leaks ☐ Debris

cracked bench hole in pipe

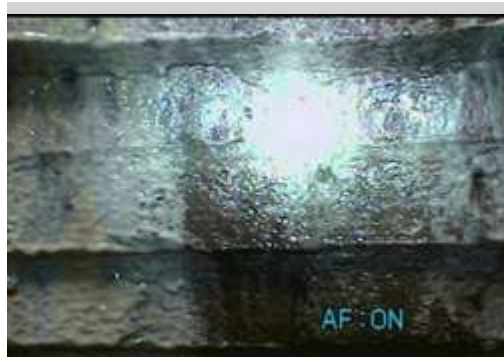
Defect 5

Infiltration: ☐ None ☒ **Joint** ☐ Cracks ☐ Mortar ☐ Roots ☒ **Wall**

barrel infiltration from joint at wall

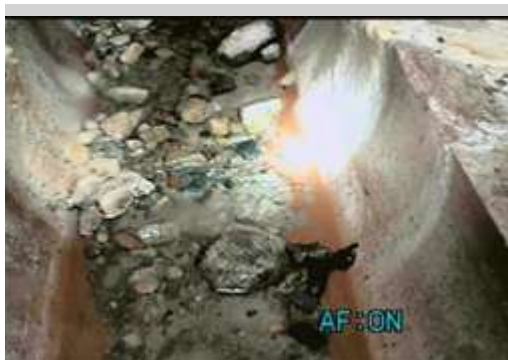
Defect 4

Condition: ☐ Sound ☐ Cracked ☐ Root Intrusion ☐ Deteriorated ☐ Leaks ☒ **Debris**

channel debris

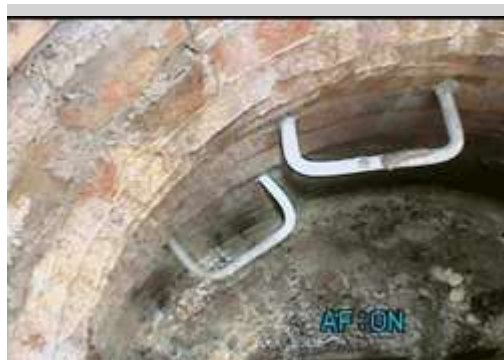
Defect 3

Count: **2** Missing: **0** ☒ **Corroded**

corroded steps

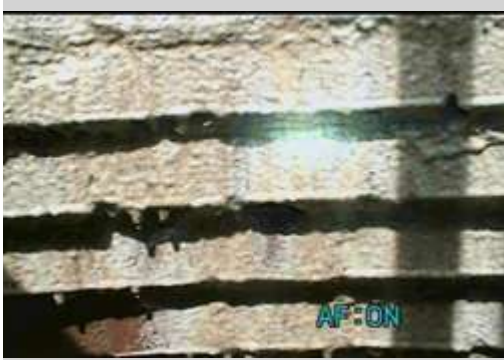
Defect 2

Infiltration: ☐ None ☒ **Joint** ☐ Cracks ☒ **Mortar** ☐ Roots ☐ Wall

corbal infiltration from joint & mortar

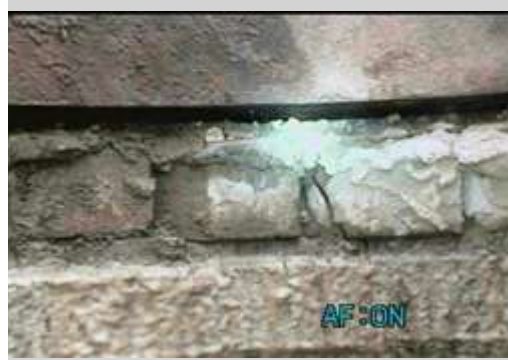
Defect 1

Condition: ☐ Sound ☒ **Cracked** ☐ Root Intrusion ☒ **Loose Brick** ☐ Deteriorated

chimney cracked, loose bricks frame adj
